# Environmental Projects: Volume 4

## Asbestos Survey

Goldstone Deep Space Communications Complex

Jet Propulsion Laboratory  
California Institute of Technology  
Pasadena, California

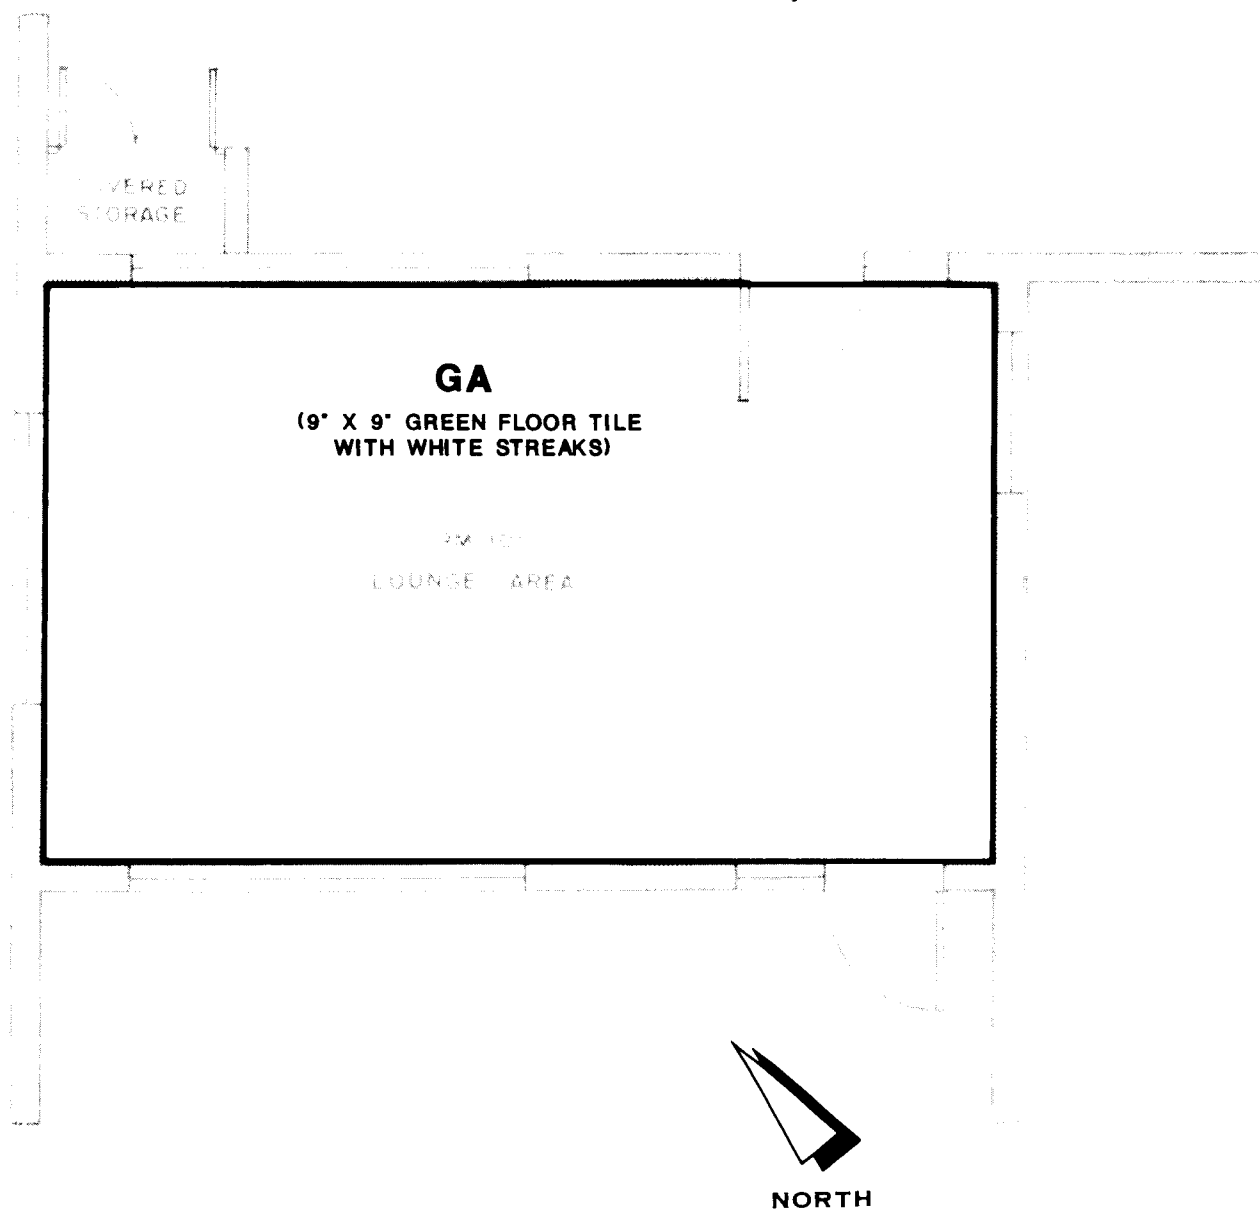
Figure 58. Goldstone Dry Lake Airport: Airport Facilities Building G-71.

Comments: 9 X 9 in. GREEN TILE WITH WHITE STREAKS. SEE FIGURE 58

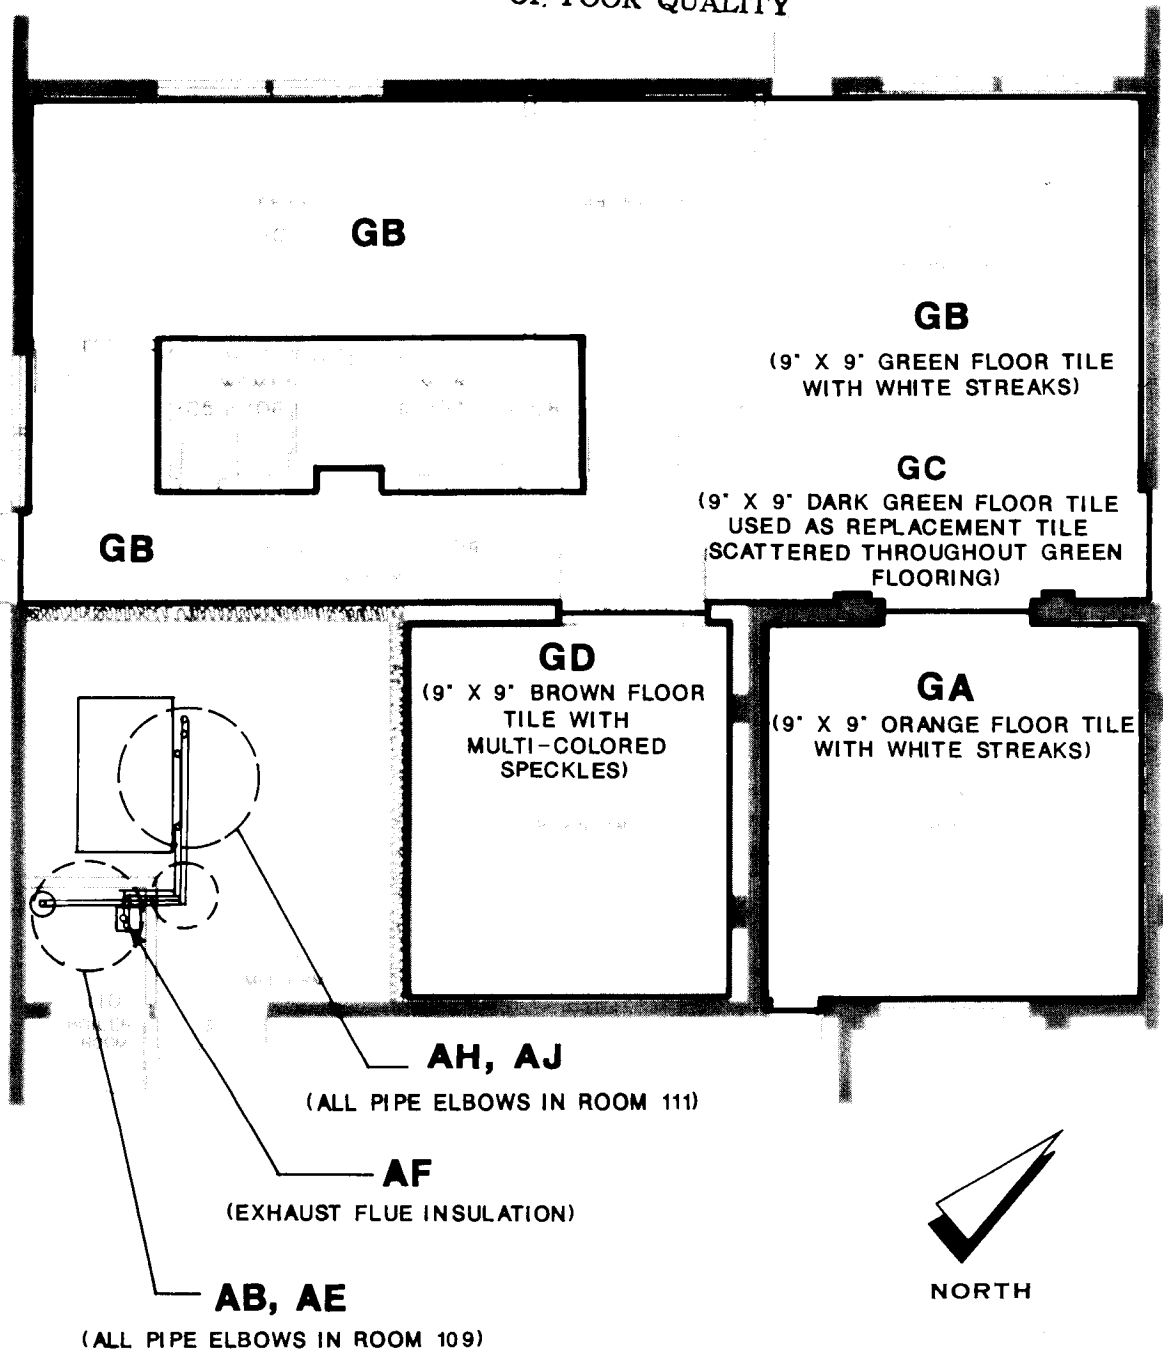
Figure 60. Microwave Test Facility: Microwave Test Facility Building G-72.

Comments: ELBOW OF HARD CEMENTITIOUS MATERIAL; OTHER AREAS OF PIPING ALSO MADE OF SAME MATERIAL. SEE FIGURE 60

Comments: ELBOW OF HARD CEMENTITIOUS MATERIAL. SEE FIGURE 60

Comments: HEATER EXHAUST VENT FLUE COVERING. SEE FIGURE 60

Comments: 9 X 9 in. ORANGE TILE WITH WHITE STREAKS. SEE FIGURE 60

Comments: 9 X 9 in. LIGHT GREEN TILE WITH WHITE STREAKS. SEE FIGURE 60

Comments: 9 X 9 in. DARK GREEN TILE USED AS REPLACEMENT TILE.  
SEE FIGURE 60

Comments: 9 X 9 in. BROWN TILE WITH MULTI-COLORED SPECKLES. SEE FIGURE 60

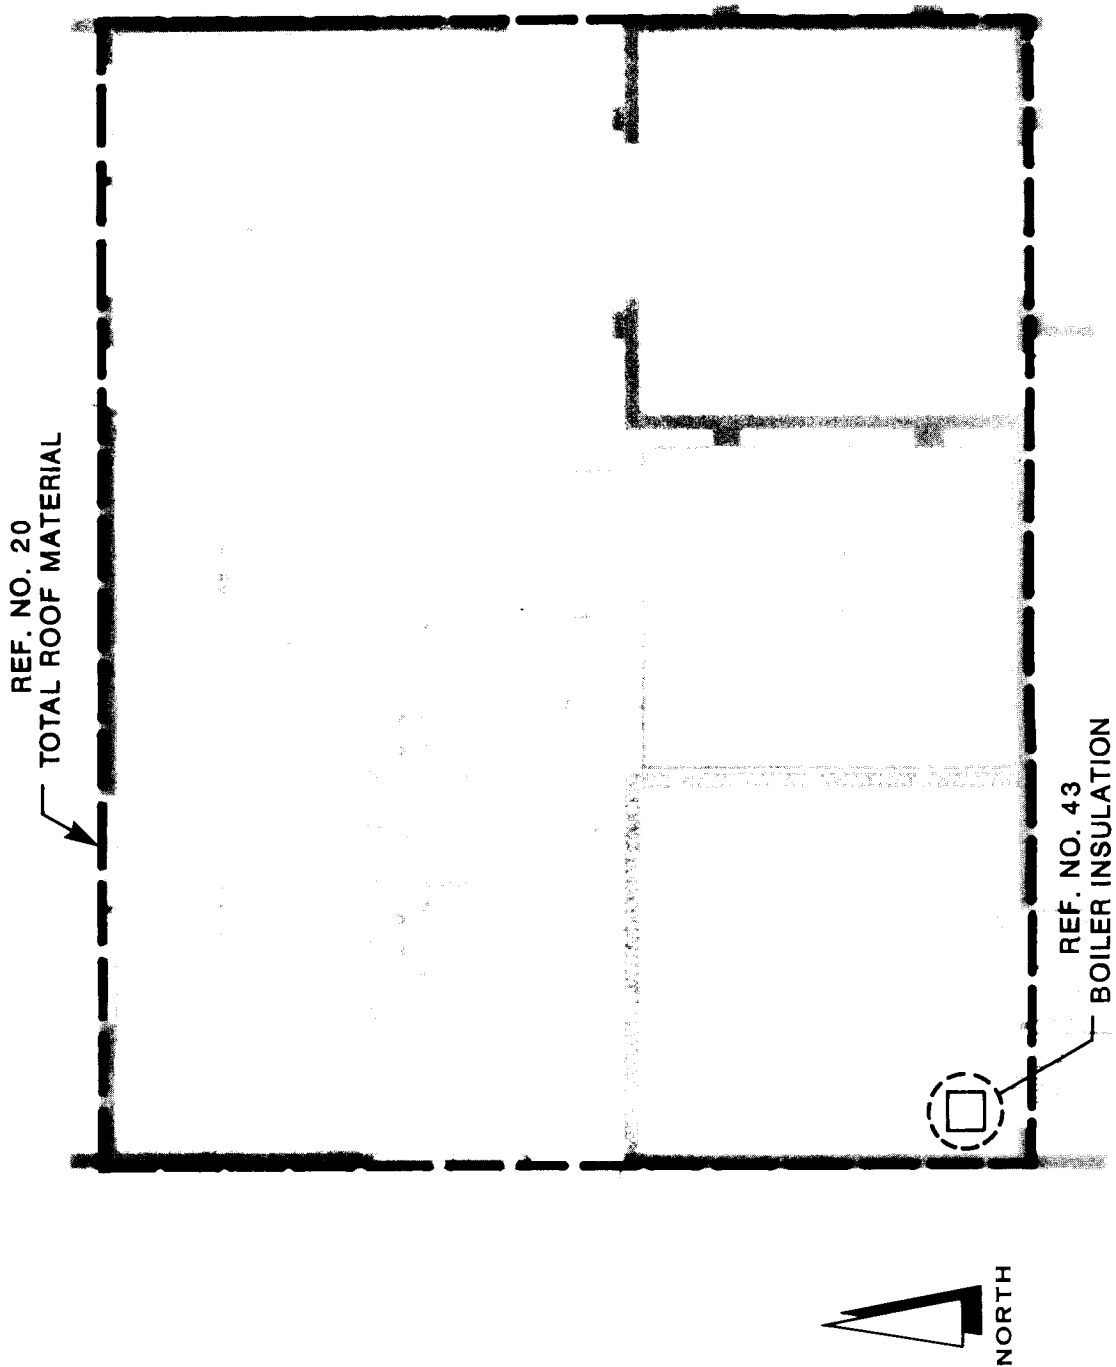
Figure 61. Microwave Test Facility: Microwave Test Facility Building G-72.

Comments: BOILER ROOM ACCESSED FROM OUTSIDE AND IS IN A TIGHT SPACE.  
SEE FIGURE 61

Comments: ROOF MATERIAL COVERED WITH TAR. SEE FIGURE 61

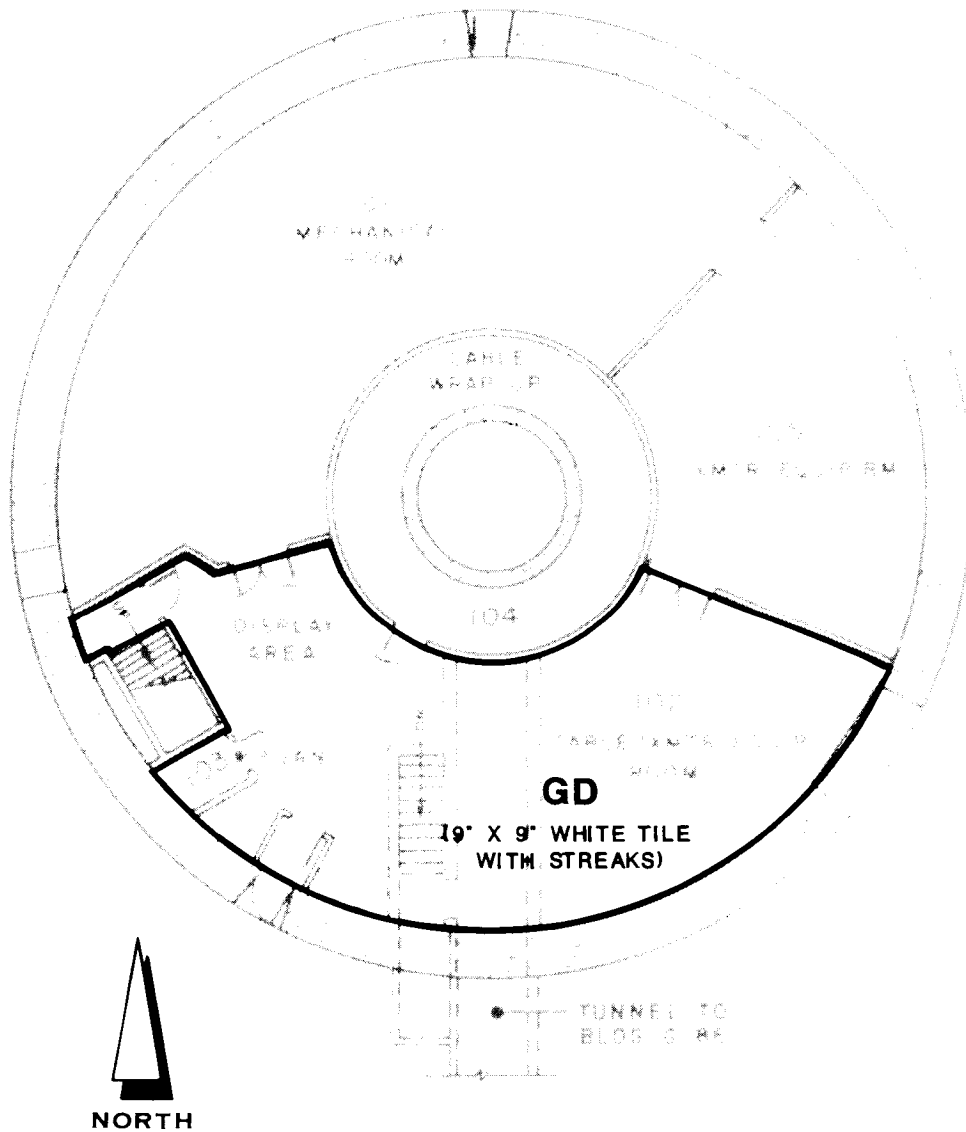
Figure 66. Mars Site: Building G-80, First Floor.

(See Figure 66)

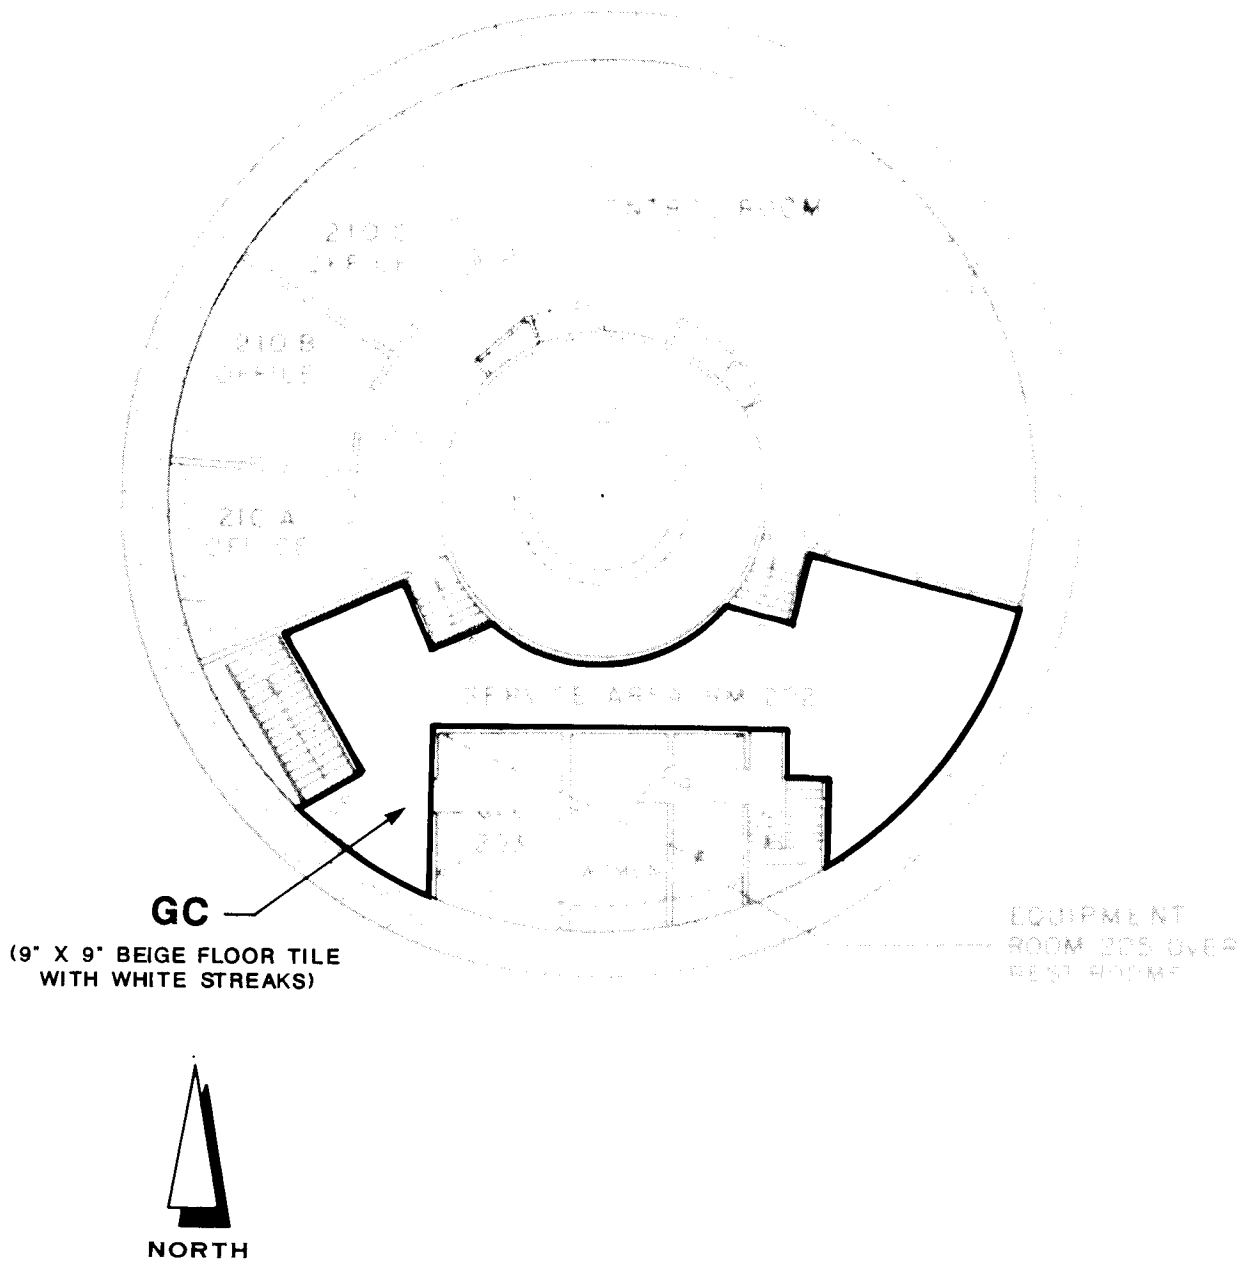
Figure 67. Mars Site: Building G-80, Second Floor.

Comments: 9 X 9 in. BEIGE TILE WITH WHITE STREAKS. SEE FIGURES 65 AND 67

(See Figure 67)

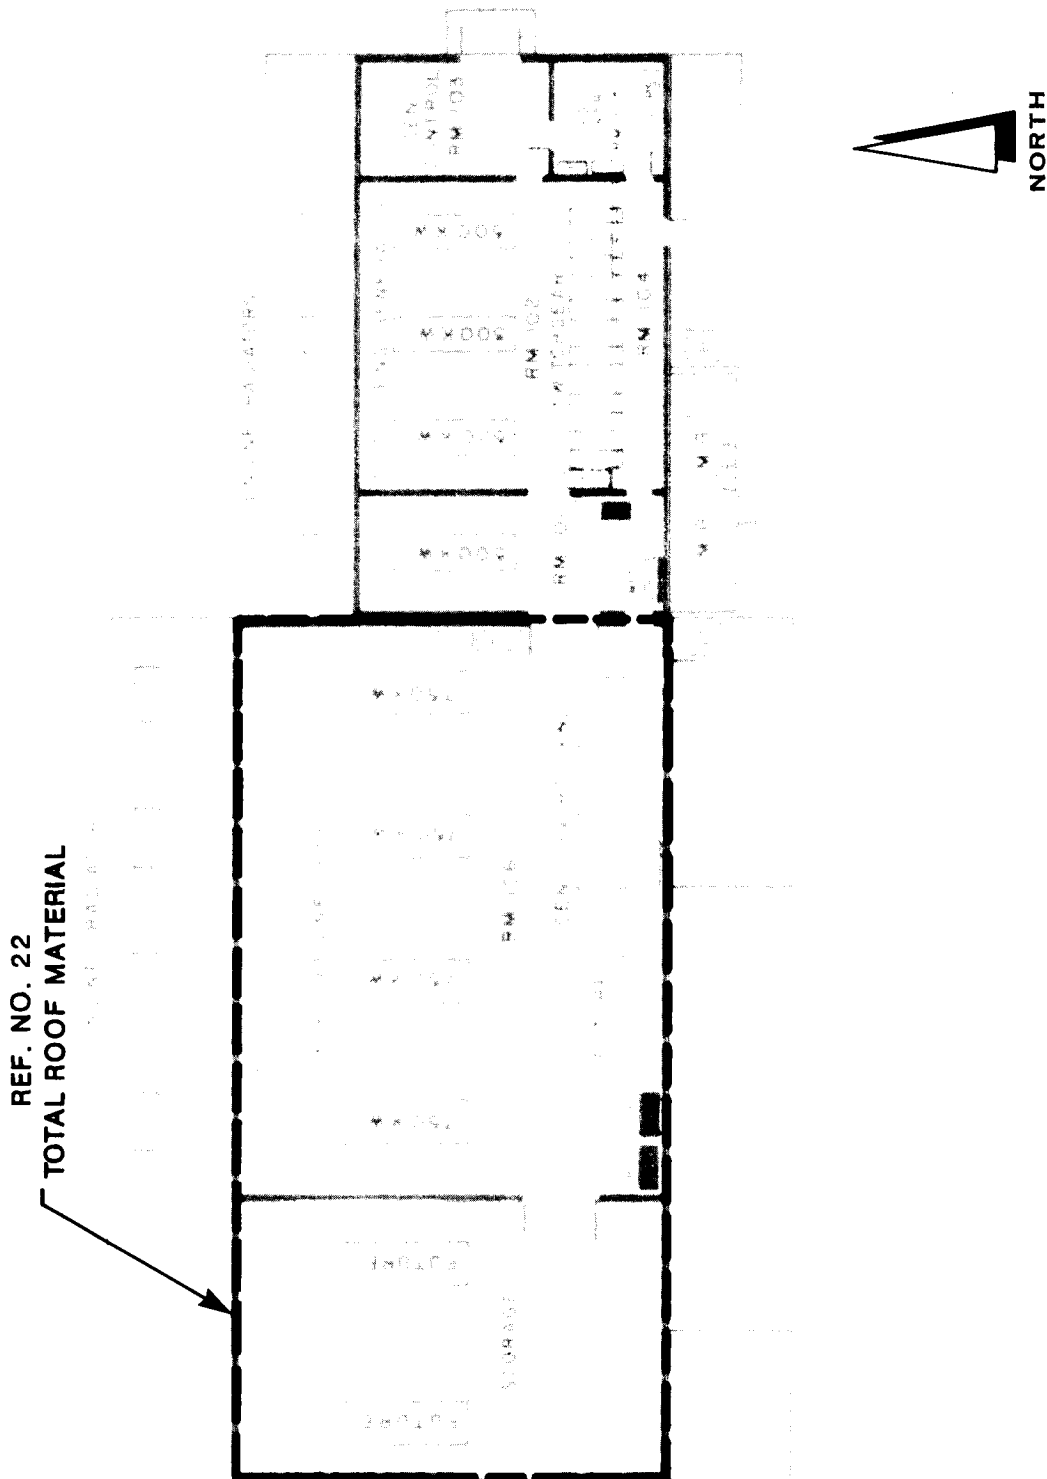
Figure 69. Mars Site: Generator Building G-81.

Asbestos-containing material found in: ROOFING  
Friable or non-friable: Non-friable  
Surface area (SF): 5,000  
Thickness of material (in.): 3.75  
Estimated volume (CF): 1562.5  
Condition of material: Some physical damage (scuffs, tears, bruises)  
Types of coatings present: None  
Building use near asbestos: Support  
Work population: None  
Ventilation: Natural  
Accessibility to area: > 8-ft ladder  
Obstructions to area: Permanent equipment/furnishings/structures  
Physical disturbances: Normal vibrations from fans, closing doors, noise, etc.  
Presence of sensitive equipment: No  
Suggested abatement timing: At time of demolition  
Suggested abatement method: Removal  
Suggested airborne monitoring: None required under normal conditions

Comments: ROOF MATERIAL COVERED WITH TAR. SEE FIGURE 69

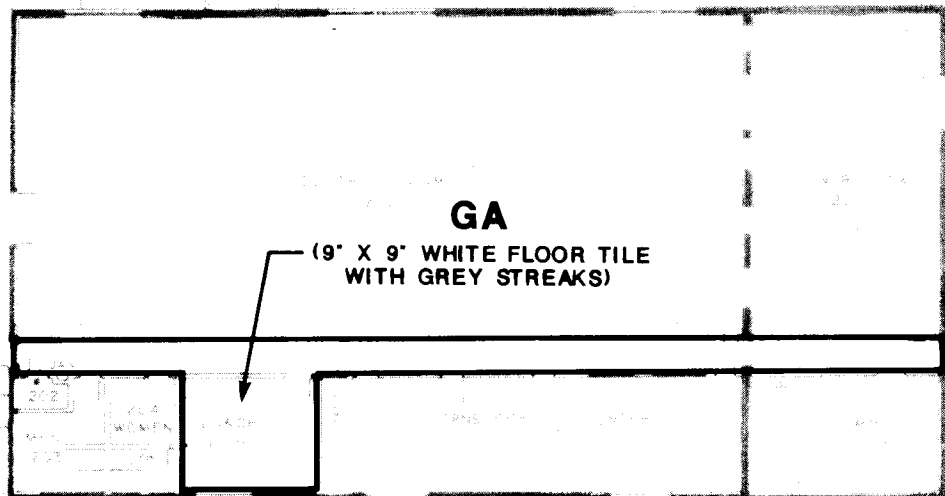
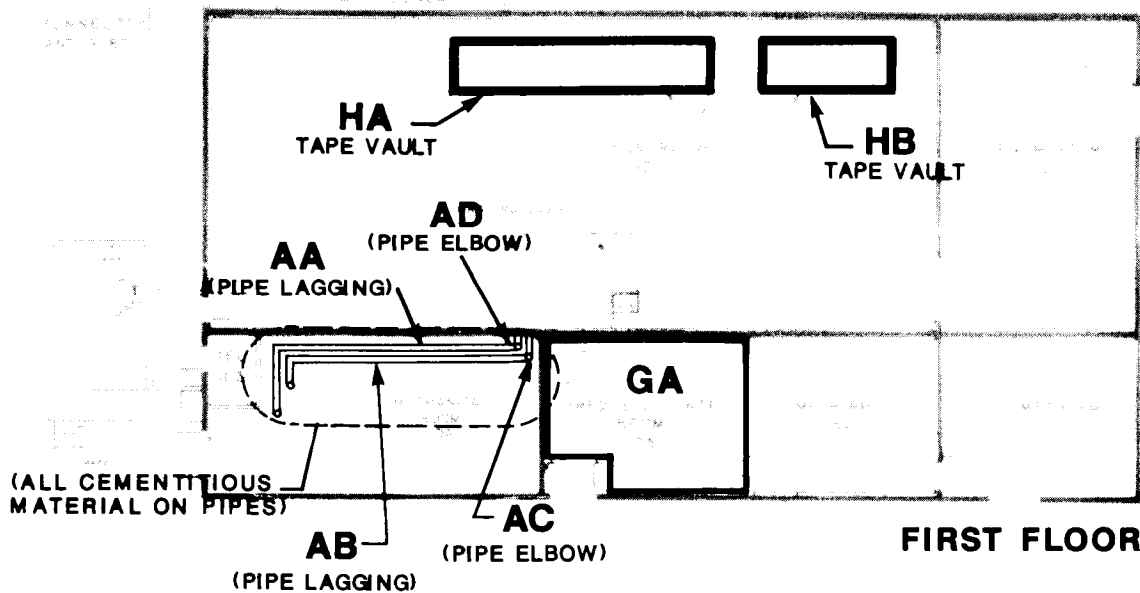
Figure 70. Mars Site: Operations Support Building G-86.

Comments: STRAIGHT PIPE LAGGING HARD CEMENTITIOUS MATERIAL. SEE FIGURE 70

Comments: STRAIGHT PIPE LAGGING HAS HARD CEMENTITIOUS MATERIAL.  
SEE FIGURE 70

Comments: ELBOW HARD CEMENTITIOUS MATERIAL. SEE FIGURE 70

Comments: ELBOW HAS HARD CEMENTITIOUS MATERIAL. SEE FIGURE 70

Comments: TAPE VAULT WALLS ARE IN GOOD CONDITION. MAINTAIN A GOOD PROTECTIVE COATING ON WALLS. SEE FIGURE 70

Comments: 9 X 9 in. WHITE TILE WITH GRAY STREAKS. SEE FIGURE 70

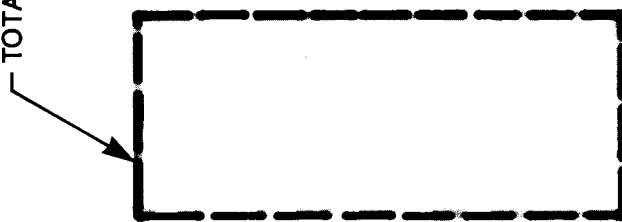
Figure 71. Mars Site: Operations Support Building G-86.

Asbestos-containing material found in: ROOFING  
Friable or non-friable: Non-friable  
Surface area (SF): 1,440  
Thickness of material (in.): 4.25  
Estimated volume (CF): 510  
Condition of material: Some physical damage (scuffs, tears, bruises)  
Types of coatings present: None  
Building use near asbestos: Support  
Work population: None  
Ventilation: Natural  
Accessibility to area: > 8-ft ladder  
Obstructions to area: Permanent equipment/furnishings/structures  
Physical disturbances: Normal vibrations from fans, closing doors, noise, etc.  
Presence of sensitive equipment: No  
Suggested abatement timing: At time of demolition  
Suggested abatement method: Removal  
Suggested airborne monitoring: None required under normal conditions

Comments: ROOF MATERIAL COVERED WITH TAR. SEE FIGURE 71

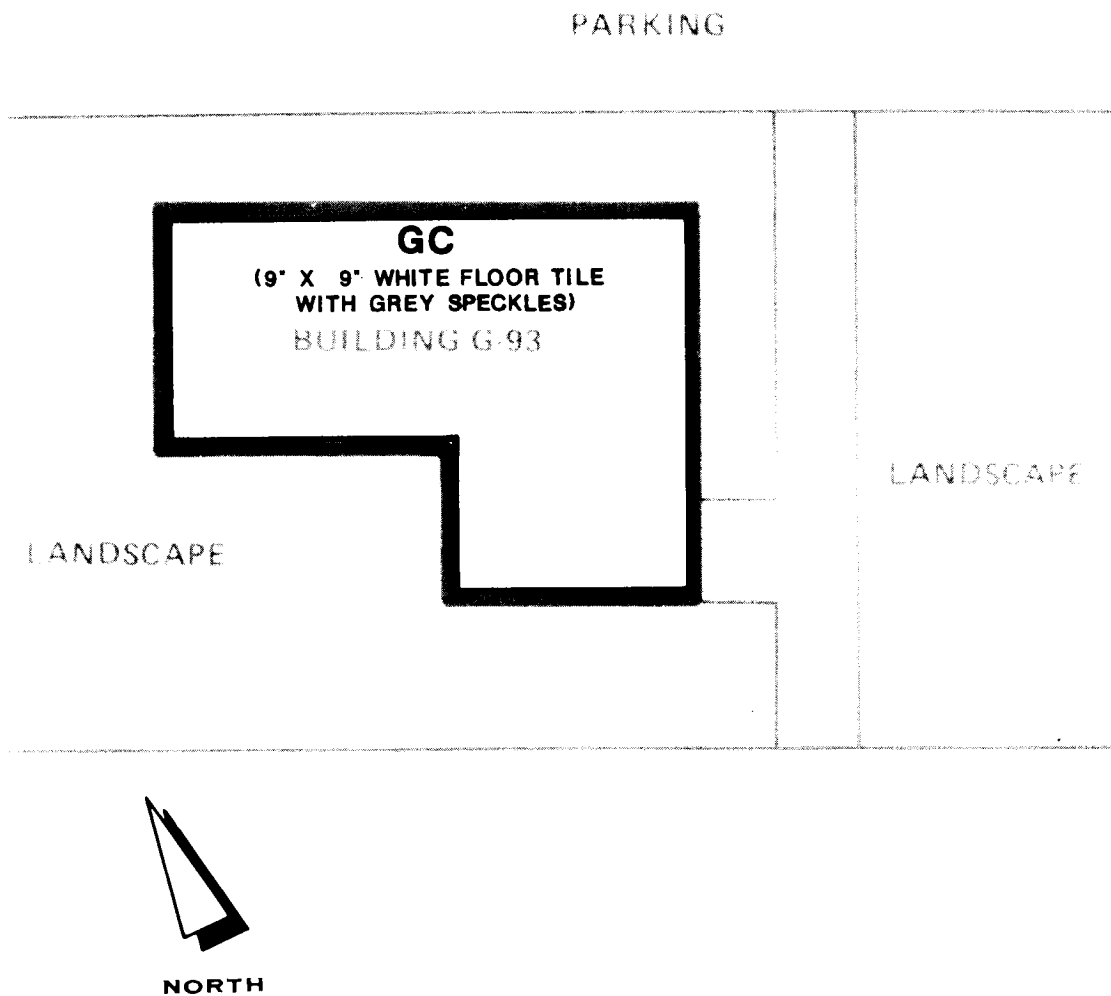
Figure 75. GDSCC: Main Gate House Building G-93.

Comments: 9 X 9 in. WHITE TILE WITH GRAY SPECKS, AS IN G-42  
SEE FIGURE 75

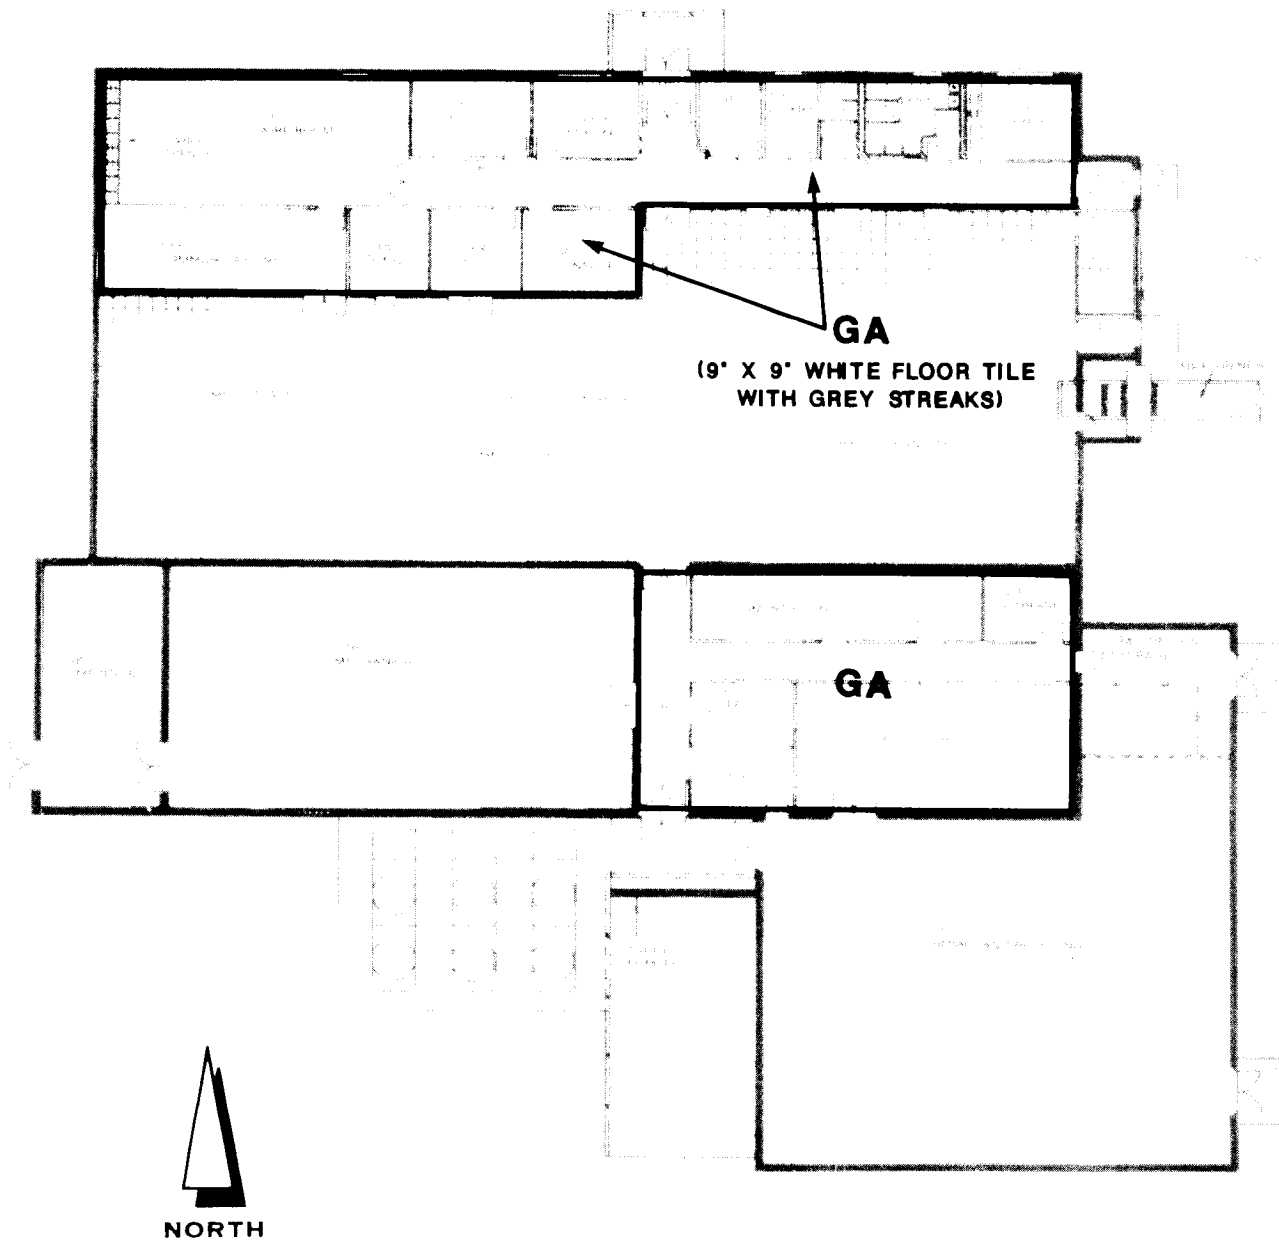
Figure 78. Apollo Site: Operations Building A-1.

Comments: 9 X 9 in. WHITE TILE WITH GRAY STREAKS. SIMILAR TO REPLACEMENT TILE USED IN BUILDING M-1. SEE FIGURE 78

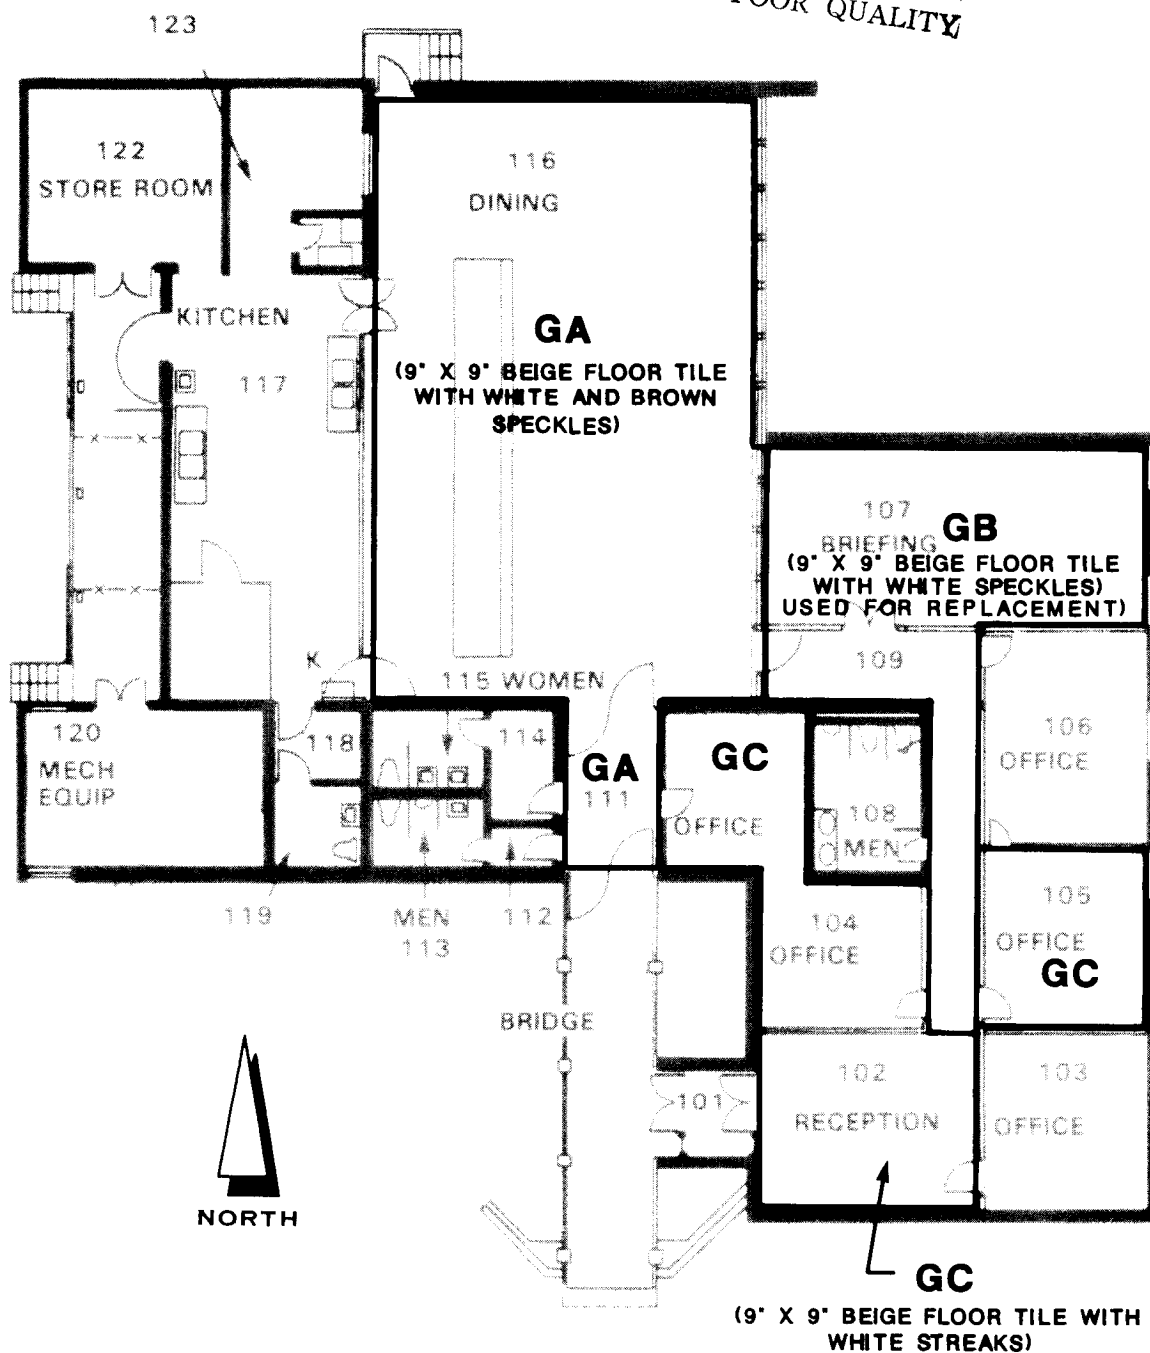
Figure 79. Apollo Site: Cafeteria and Administration Building A-2.

Comments: 9 X 9 in. BEIGE TILE WITH WHITE AND BROWN SPECKS. SEE  
FIGURE 79

Comments: 9 X 9 in. BEIGE TILE WITH WHITE SPECKS. USED FOR REPLACEMENT. SEE FIGURE 79

Comments: 9 X 9 in. BEIGE TILE WITH WHITE SPECKS. SEE FIGURE 79

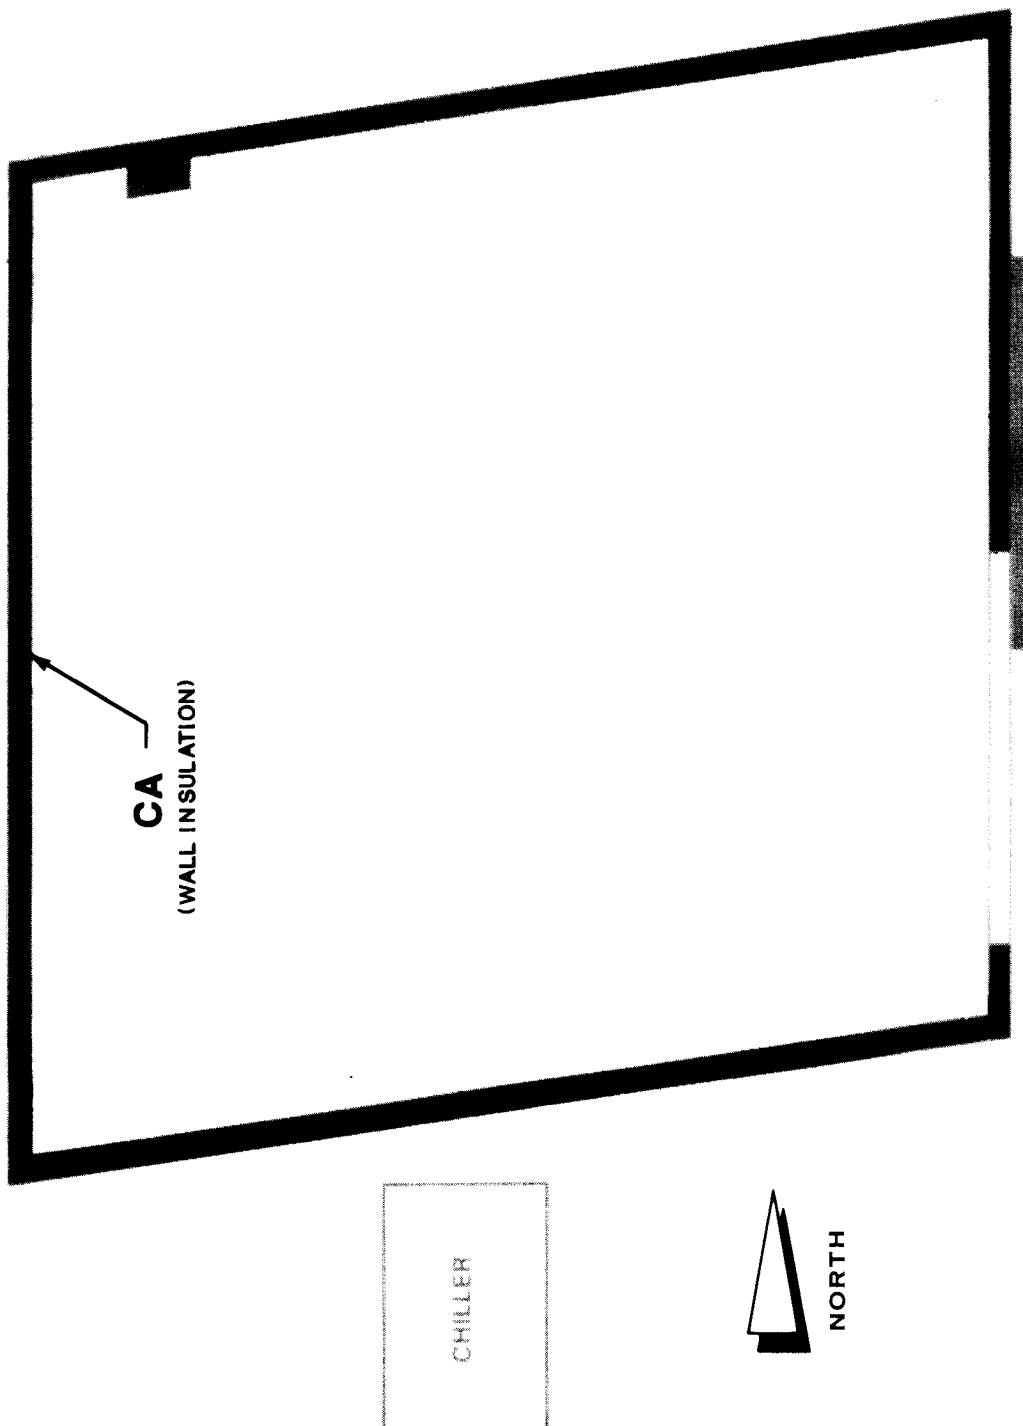
Figure 80. Apollo Site: 9-Meter Antenna Equipment Building A-7.

Comments: WALL INSULATION HAS TRACE QUANTITY OF ASBESTOS. SEE FIGURE 80

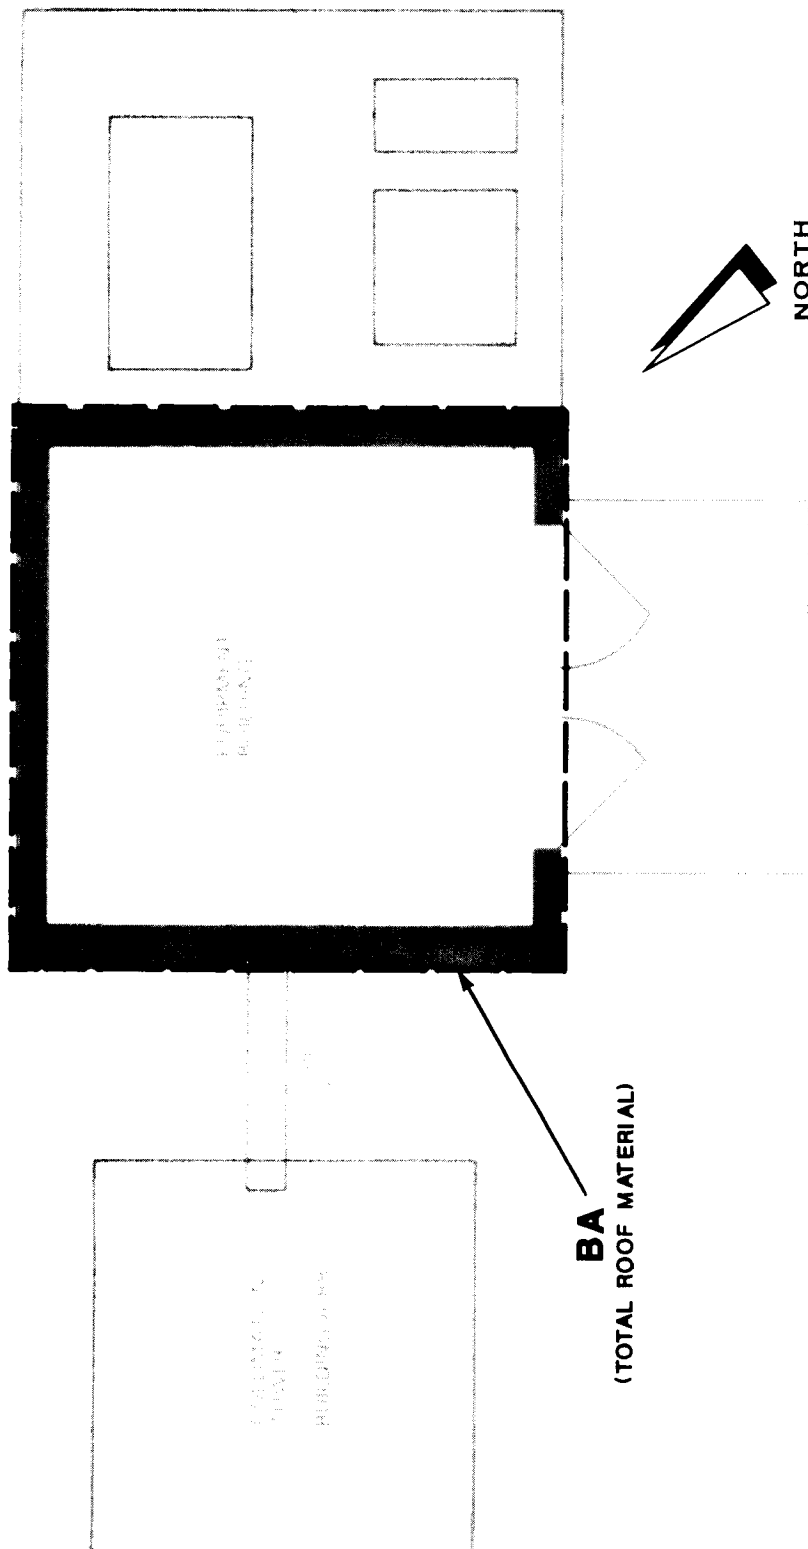
Figure 83. Apollo Site: 9-Meter Antenna Collimation Tower Building A-8.

Comments: ROOF MATERIAL COVERED WITH TAR AND GROUND PEBBLES.  
SEE FIGURE 83

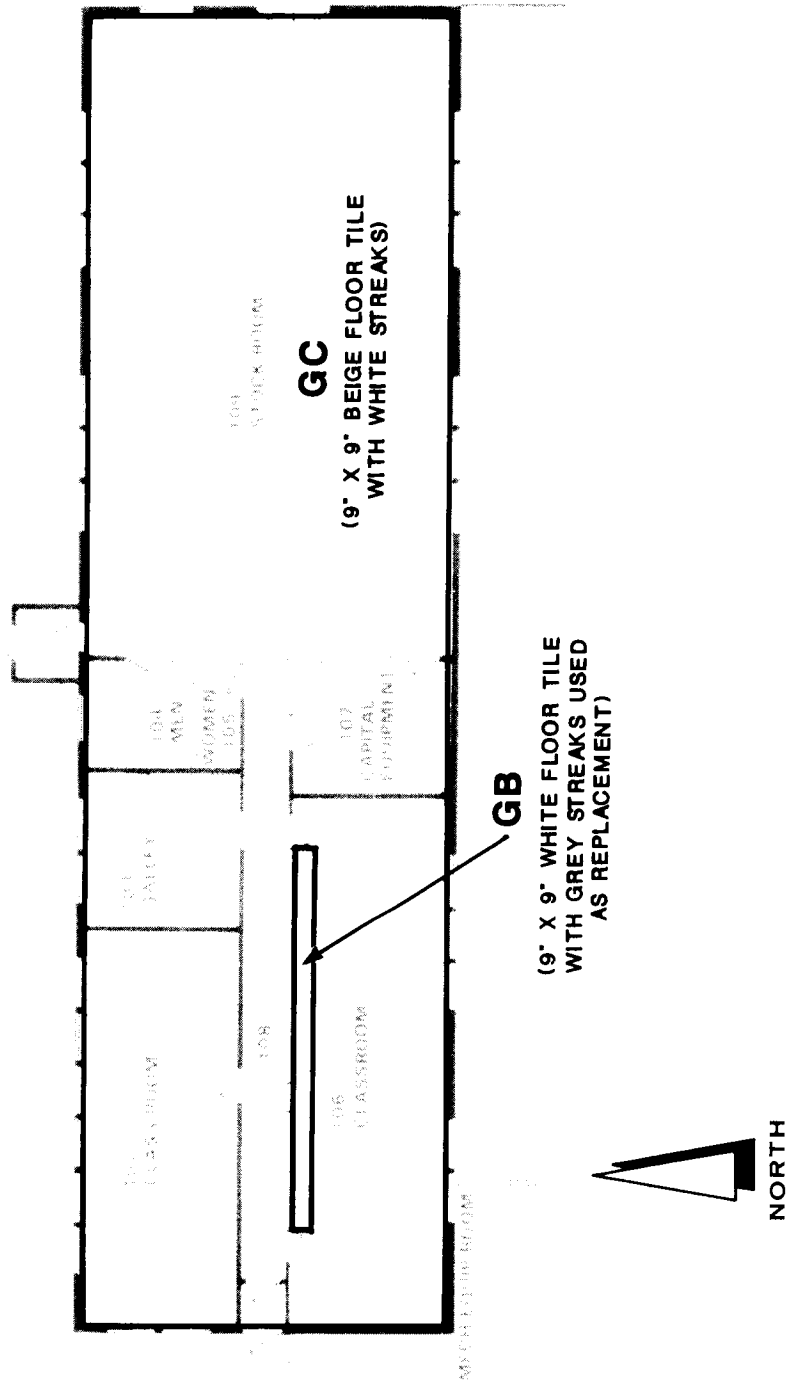
Figure 85. Mojave Base Site: Minitrack Building M-1.

Comments: 9 X 9 in. WHITE TILE WITH GRAY STREAKS. USED AS REPLACEMENT TILE. SEE FIGURE 85

Comments: 9 X 9 in. BEIGE TILE WITH WHITE STREAKS. SEE FIGURE 85

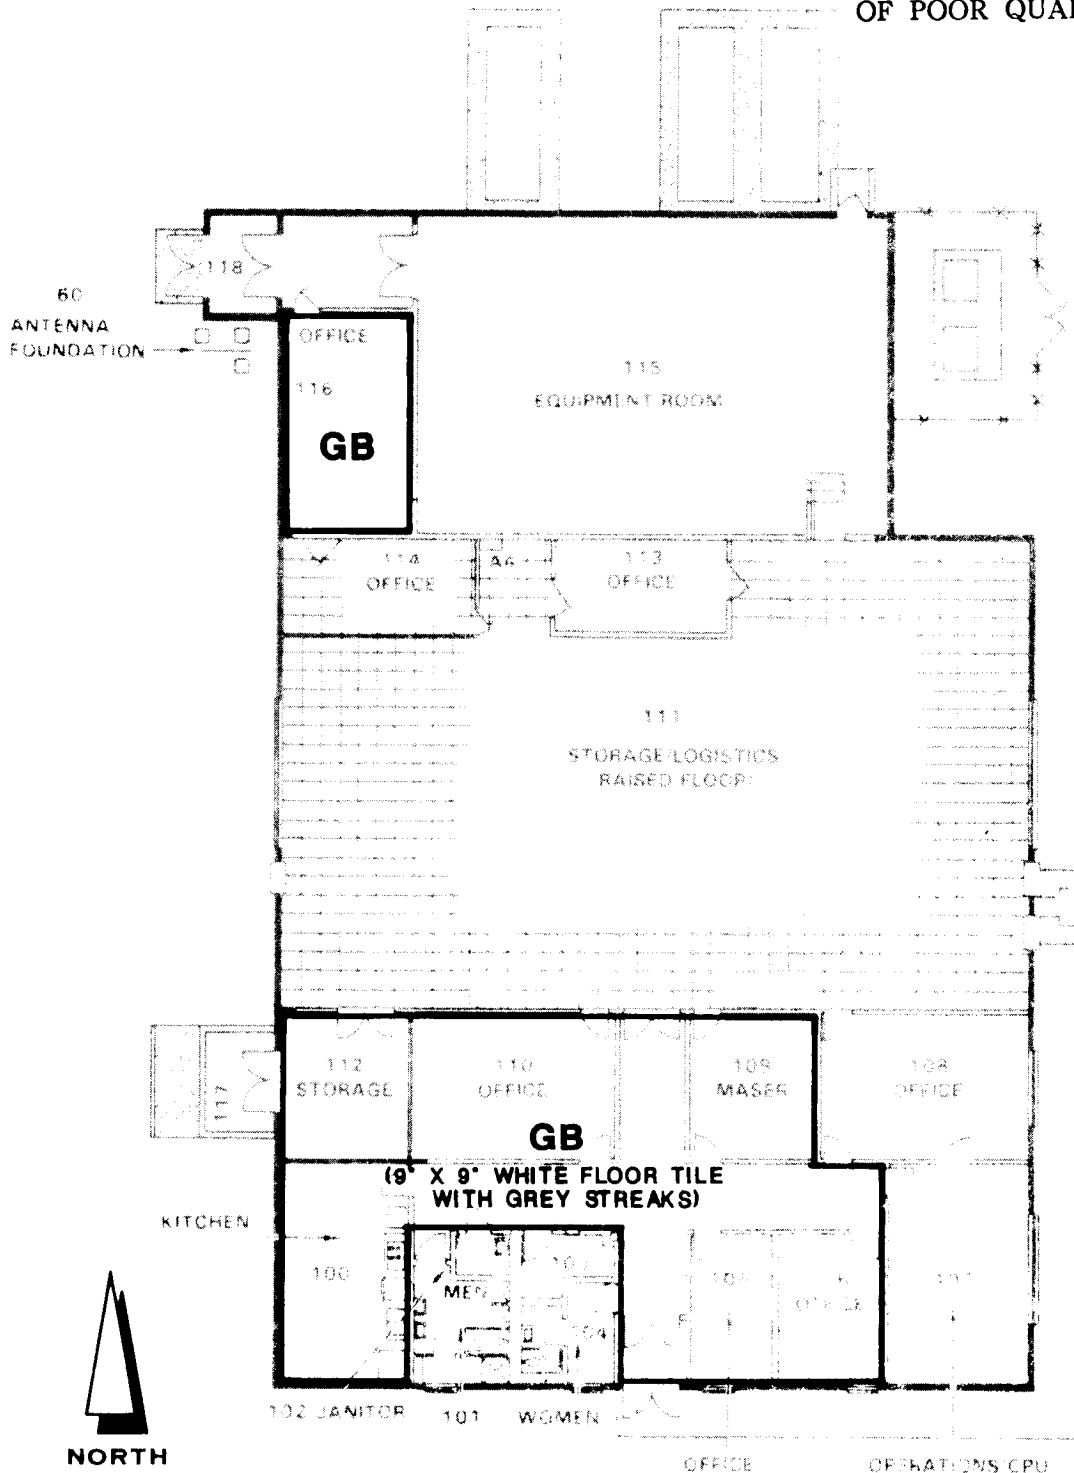
Figure 89. Mojave Base Site: Operations Building M-8.

Comments: 9 X 9 in. WHITE TILE WITH GRAY STREAKS. SEE FIGURE 89

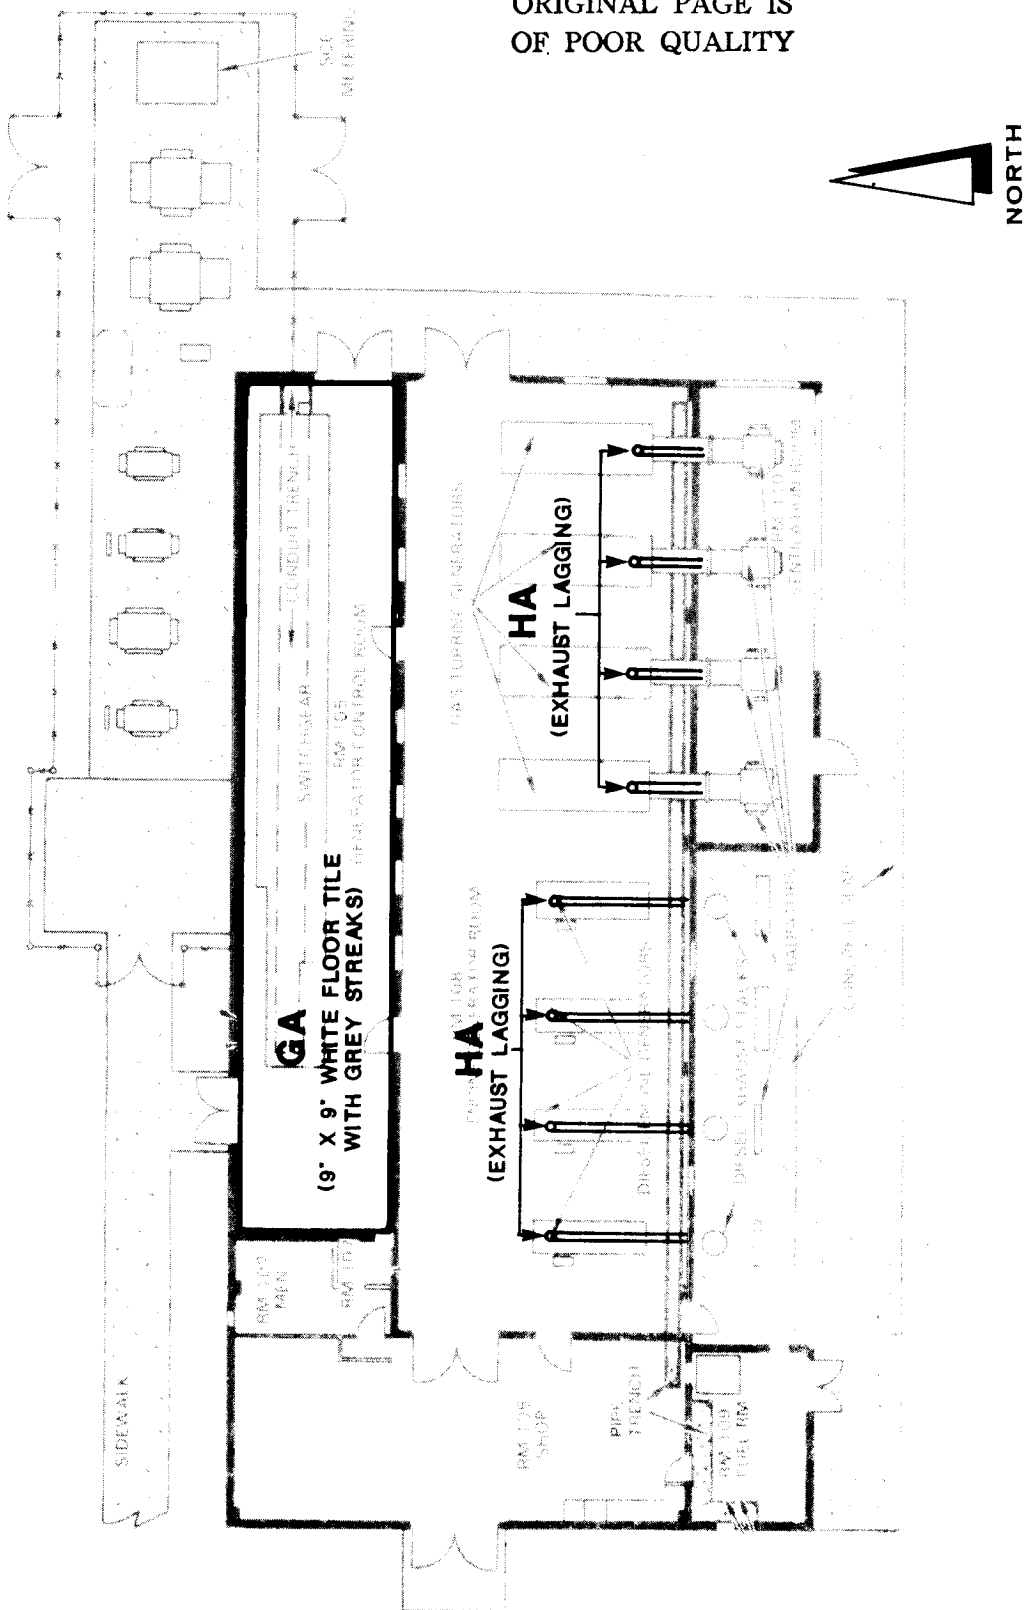
Figure 90. Mojave Base Site: Generator Building M-9.

Comments: 9 X 9 in. WHITE TILE WITH GRAY STREAKS. SEE FIGURE 90
